Physical Condition Assessment Matrix

In this context, the Board of Education from Downers Grove School District 58 invited Wight & Company, to conduct an independent, two-part assessment of its fifteen (15) facilities. Specifically, the Board directed Wight to investigate and document the physical condition of the building and site components at all of its campuses and benchmark the performance characteristics of each facility against recognized 21st Century educational practices.

A survey was conducted to identify the physical condition of the existing systems and components at each building and to provide recommendations for capital improvements over the next 15 years. A *Physical Conditions Summary Worksheet (shown below)* was created to itemize observations from the building tours and information collected from school district staff.

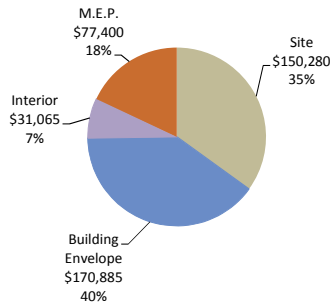
Site: The site is shared with Indian Trail Elementary School. The site is surface drained with no detention. The roof area drains to internal downspouts to the municipal storm system. Parking surfaces are paved. Parking lot pavement needs to be replaced. The concrete entry needs to be replaced.

Building Envelope: The structure is load bearing precast concrete panels. Windows are single glazed. The roof is a single ply membrane. The exterior entrance is aluminum and in good condition.

Mechanical, Electrical, Plumbing, Fire Protection: Ventilation is provided via three packaged rooftop units with cooling. There are two separate humidifiers in the open office areas. Domestic hot water is provided via an electric water heater. Roof storm water is drained to interior downspouts connected to the municipal system. There is not central sprinkler system. There is one electrical service. General power, intercom, and fire alarm are adequate. Security is limited to intrusion control.

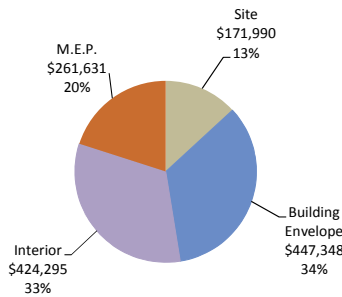
Site: The site is surface drained with no detention. The roof area drains to internal downspouts to the municipal storm system. Parking surfaces are paved. The pavement at one parking lot needs to be replaced. There are many mature trees on this site.

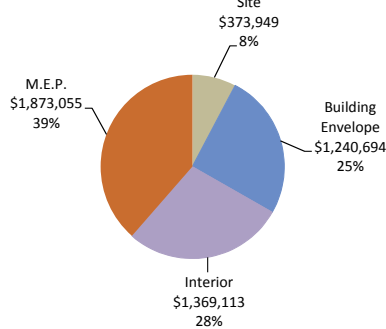
Site: The site is surface drained. There is no site detention. The majority of the roof area drains to the site via internal downspouts directly to the municipal storm system. Parking and playground surfaces are paved. Bus traffic and automobile traffic are separated. Some parking pavement need to be replaced. Site lighting is limited.

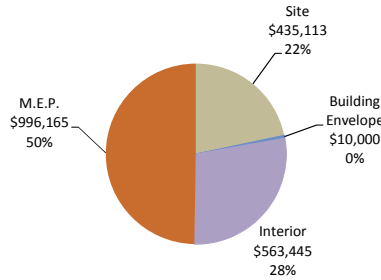
Site: The site is surface drained with no detention. The majority of the roof area drains to the site via downspouts to grade. Parking and playground surfaces are paved. Bus traffic and automobile traffic share circulation routes. Pavement is in good condition. The parking lot lighting is limited. The playground equipment is new with the exception of swings. There is a fence on the west property line that is being damaged by shrubs and trees.

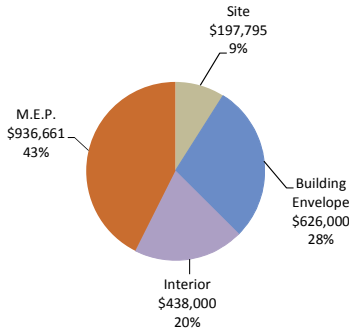
Site: The site is surface drained to the municipal storm system. There is no site detention. The majority of the roof area drains to the site via downspouts to grade. Parking and playground surfaces are paved. Bus traffic and automobile traffic share circulation routes. Playground pavement needs to be replaced. The playground equipment is new with the exception of swings.

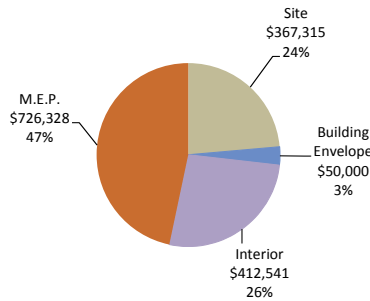
Site: The site is surface drained. There is no site detention. The majority of the roof area drains to the site via internal downspouts with some areas having downspouts to grade. Parking and playground surfaces are paved. Bus traffic and automobile traffic are separated. Parking pavement needs to be replaced. The playground equipment is in good condition. Site lighting is limited.
